**Flood Control Project Maintenance  
Levee Inspections**

## Maintenance Issue Types Only, Levee Inspection Report By Mile - Spring 2019

### Reclamation District No. 0003 Grand Island

Waterway	Bank	Unit Miles	Inspection Start/End	Inspector
Unit No. 01 Left Bank Steamboat Slough	Left	10.95	04/03/2019 04/03/2019	David Julian

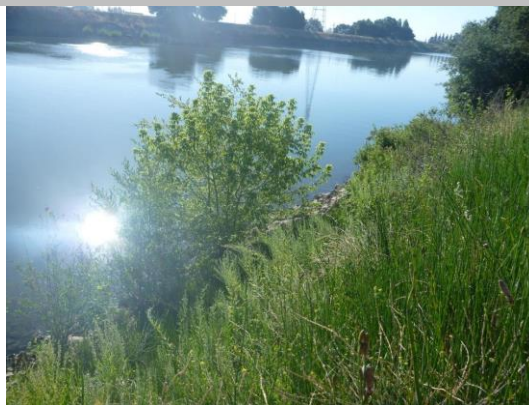
Photo 2 of 2 : SP\_2019\_RD0003\_25\_150\_20190311\_00127.jpg

LM Start	16.54	Rating **	A/W	Issue No.	150
LM End	16.56	Issue Type +	Ma	Location *	
Category	Supplemental			GPS Latitude/Longitude	
				Start	End
Item	2017 Storm Damage			38.294717 °	38.294986 °
				-121.565417 °	-121.565661 °
DWR ID	DWR_RD0003_02_f_2017_150				
Comment Code					
Inspector Comment					
Levee Evaluation Comments					
Description:District station 873+61 to 874+83, Sec. 08, T. 5 N. R. 4 E., M.D.M. Approximately 122 linear feet of erosion exists along the water side slope of the Sacramento River (Unit 2). The erosion commences approximately 1/2 of the way down the slope from the crown and extends beyond the rip rap. A section of rip rap has eroded away in this location.					
Site ID No:284					
Site Designation:LMA-110					
Repair Type: Erosion					
Rating:Area of Concern					
Field Date:7/28/2017					
Notes: no berm

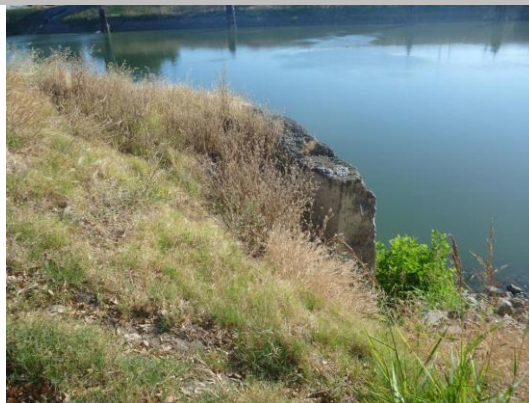
Photo 1 of 3 : SP\_2019\_RD0003\_25\_152\_20190311\_00130.jpg

LM Start	16.90	Rating **	A/W	Issue No.	152
LM End	16.90	Issue Type +	Ma	Location *	
Category	Supplemental			GPS Latitude/Longitude	
				Start	End
Item	2017 Storm Damage			38.298914 °	38.298997 °
				-121.569156 °	-121.569217 °
DWR ID	DWR_RD0003_02_f_2017_152				
Comment Code					
Inspector Comment					
Levee Evaluation Comments					
Description:District station 892+36 to 892+70, Sec. 08, T. 5 N. R. 4 E., M.D.M. Approximately 34 linear feet of erosion exists along the water side slope of the Sacramento River (Unit 2). The erosion commences approximately 1/2 of the way down the slope from the crown and extends into the rip rap. A section of rip rap has eroded away in this location.					
Site ID No:285					
Site Designation:LMA-111					
Repair Type: Erosion					
Rating:Area of Concern					
Field Date:7/28/2017					
Notes: highway on crown

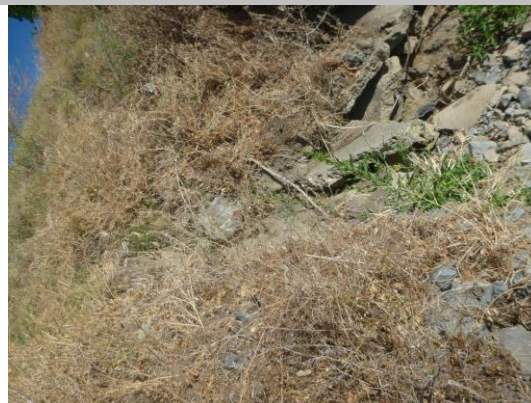
Photo 3 of 3 : SP\_2019\_RD0003\_25\_152\_20190311\_00132.jpg

LM Start	16.90	Rating **	A/W	Issue No.	152 (cont)
LM End	16.90	Issue Type +	Ma	Location *	
Category	Supplemental			GPS Latitude/Longitude	
				Start	End
Item	2017 Storm Damage			38.298914 °	38.298997 °
				-121.569156 °	-121.569217 °
DWR ID	DWR_RD0003_02_f_2017_152				
Comment Code					
Inspector Comment					
Levee Evaluation Comments					
Description:District station 892+36 to 892+70, Sec. 08, T. 5 N. R. 4 E., M.D.M. Approximately 34 linear feet of erosion exists along the water side slope of the Sacramento River (Unit 2). The erosion commences approximately 1/2 of the way down the slope from the crown and extends into the rip rap. A section of rip rap has eroded away in this location.					
Site ID No:285					
Site Designation:LMA-111					
Repair Type: Erosion					
Rating:Area of Concern					
Field Date:7/28/2017					
Notes: highway on crown

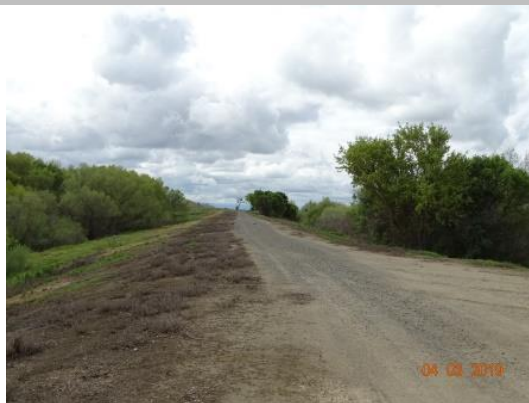
Photo 1 of 1 : SP\_2019\_RD0003\_610\_2\_20190403\_00003.jpg

LM Start	0.00	Rating **	A	Issue No.	2
LM End	0.43	Issue Type +	Ma	Location *	LS
Category	Earthen Levee			GPS Latitude/Longitude	
				Start	End
Item	Vegetation			38.182267 °	38.175989 °
				-121.653511 °	-121.653772 °
DWR ID	DWR_RD0003_03_s_2019_2				
Comment Code					
V1 : Control annual grass and weeds on the levee slopes and easements.					
Inspector Comment					
Continue to maintain annual vegetation at a high rate.

View looking downstream at annual vegetation on the landside slope (Spring 2019).
